AIRFIELDS

High-speed measurement of airfield pavement condition

Alex Wright

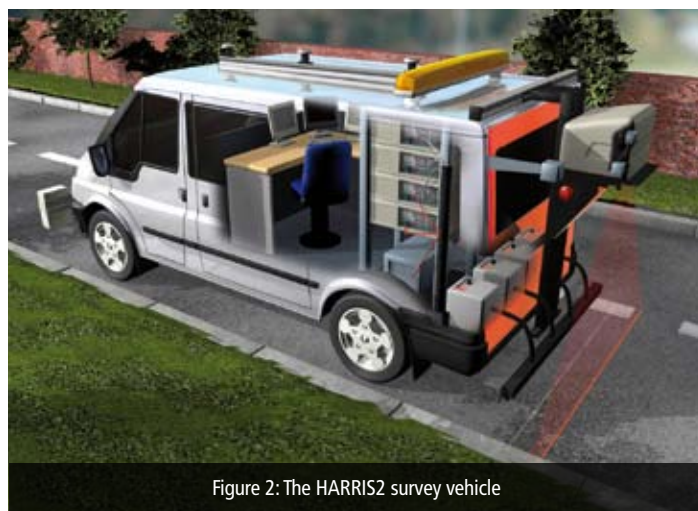
Figure 2: The HARRIS2 survey vehicle

HARRIS2. This HARRIS2 employs the latest developments in high-speed data collection, providing high-resolution colour images of the pavement, linked to a scanning laser for the measurement of shape – see Figure 2. The example images shown in Figure 3 clearly show the defects such as joint failure, spalling, and surface loss, which are easily recorded in the manual assessment.

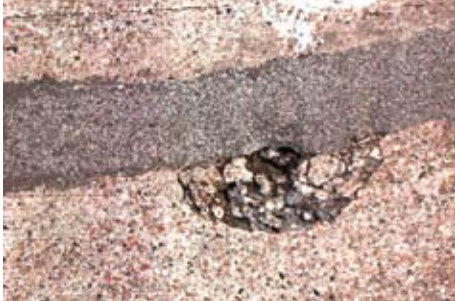
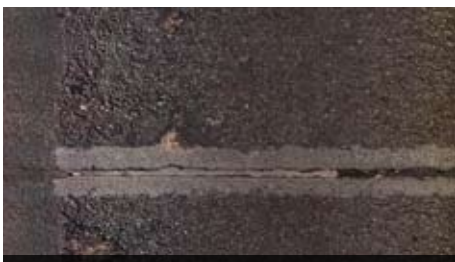
Figure 3: Surface images collected at traffic-speed
