SOIL STABILISATION

Road Recycling - A Sustainable Solution

Cambridgeshire Highways – the County Council’s highway service and its term maintenance service partner Atkins – have opted to in-situ recycle a 2km stretch of the B1040 at Ramsey St Marys.

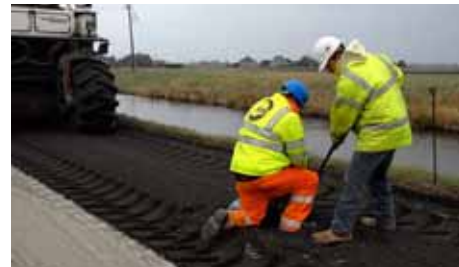
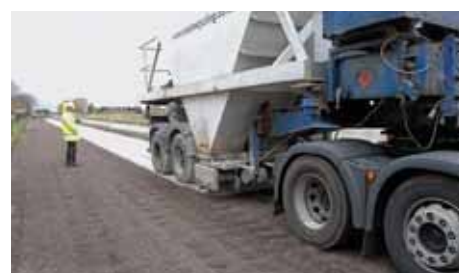
The road was planed off an initial 1000mm to accommodate the new wearing course. The Wirtgen 2500 then pulverised the road to the full 250mm treatment depth. The Wirtgen’s drum cutter was pushed into the worn-out pavement to full depth and the machine made a climbing cut leaving a 2.5m wide pulverised swath of material in its wake.

A motor grader followed on re-profiling the pulverised material which was then lightly compacted with a Hamm HD90 double drum vibratory roller. A blanket of OPC was then spread to a ratio of 6% by volume of the material’s dry density. The Wirtgen mixed the cement into the pulverised material to the full 250mm treatment depth. At the same time, water to the ratio of 4% by volume, was sucked from a bowsheer in front of the machine and injected directly

into the mix from nozzles in the crown of the Wirtgen’s rotovating drum chamber. All the ingredients were thoroughly mixed to reconstitute and strengthen the old base course.

Following laboratory testing, the strengthened mixture is then compacted, re-profiled and levelled by the grader prior to the Hamm roller compacting the newly strengthened road base to 95% of refusal density. The entire process was repeated to complete the sub-base in-situ repair. The strengthened road base is then sprayed with a sealing emulsion tack coat and covered with grit as a temporary running surface.
